# REINFORCEMENT WORKS FOR THE SLOPE STABILIZATION: STANDARD AND NEW APPROACHES FOR THE USE OF MICROPILES AND ANCHORS

## ABSTRACT

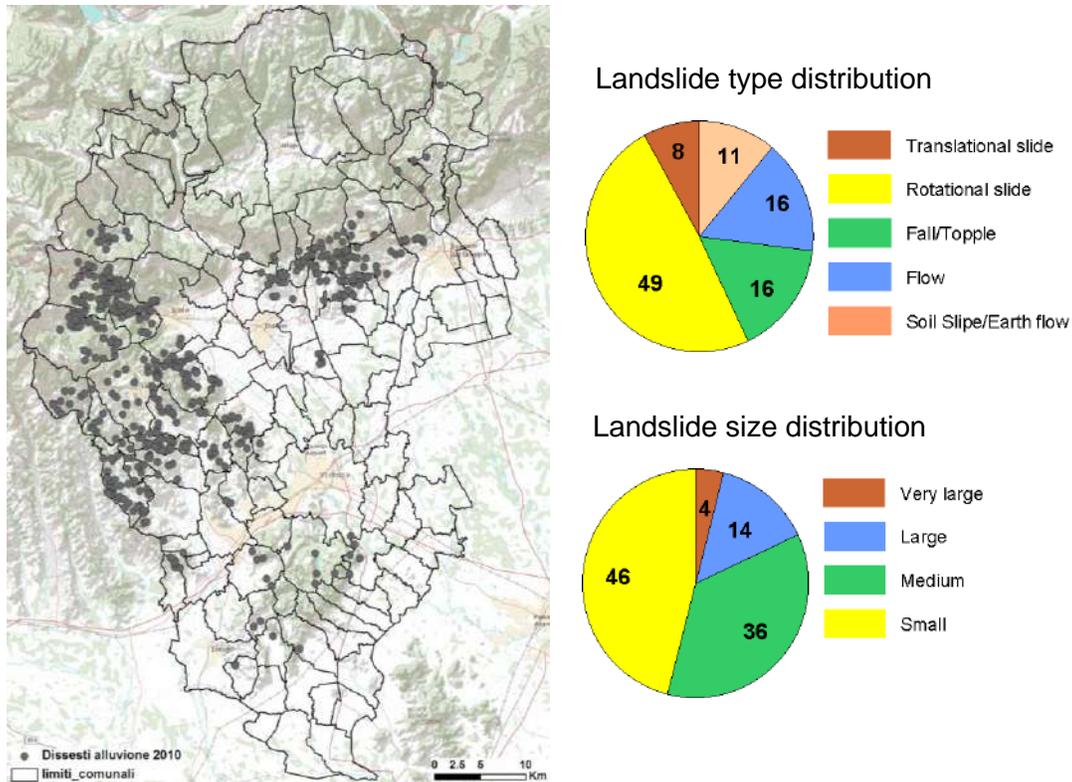
Figure 2. Distribution of landslides occurred after October 31 3 November 2, 2010, event.

of Veneto Region. The intense rainfall triggered a huge number of mass movements in the Northern and Western parts of the Vicenza Province: the Soil Protection Division (SPD) received about 500 warnings of landslides, distributed over 20 municipalities of the Vicenza Province (Figure 2).

As reported in Figure 2, all types of landslides occurred with a prevalence of rotational slides (49%) and flow phenomena (soil slip, earth flow and debris flow). The phenomena, both localized and widespread, involved only the debris cover in 70% of cases, the eluvial or colluvial layer in 28% and the rock formations in the remaining 2% of cases. The majority of phenomena had small to medium size, 46% and 36% respectively, and only the 4% of them were very large landslides. The 89% of mass movements caused damages to the road system, while in the 7% of cases private buildings were involved. The overall estimated costs for remediation works amount to about 80 millions of Euro.

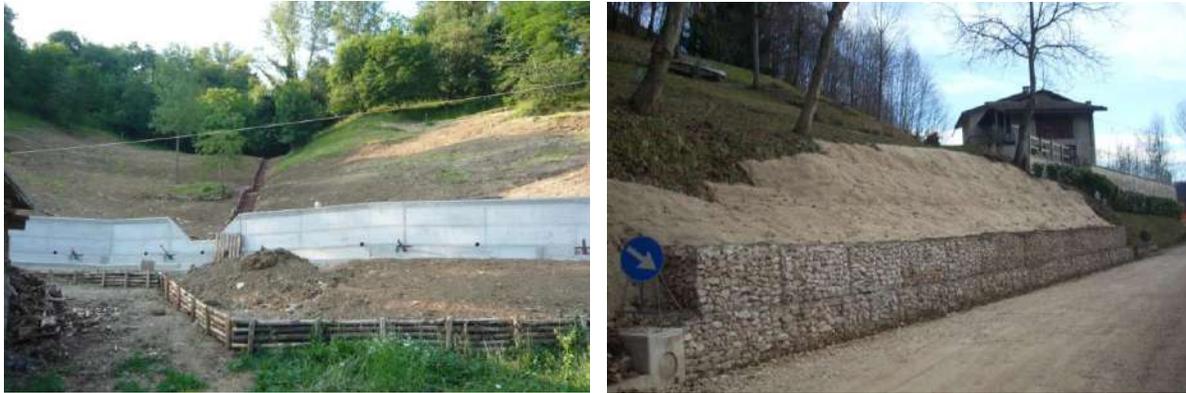
Figure 3. Examples of wall in Vicenza Province: a cantilever tied-back wall realized at Lusiana (a); a gabion wall in Valli del Pasubio (b).

In Vicenza Province all kinds of wall are used: gravity or cantilever walls, gabion walls, reinforced earth walls and tied-back walls. As showed in Figure 3, the wall are used for stabilizing small size landslides, in slope regarding intervention, sometime coupled with a dewatering system (Ferrari, 2011).

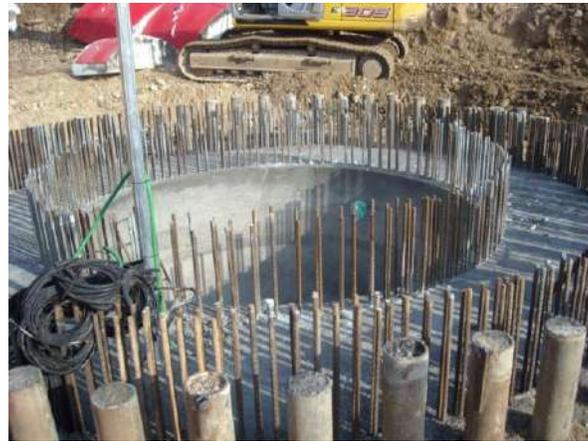
Figure 4. Realization of a structural well in Frana Fantoni (Recoaro).

Dowels are not suitable in all the slopes, because their construction requires the employment of very big boring machines. In Vicenza Province there are some examples of shear piles configured to obtain structural wells: for example, the structural well realized in 2010 for the stabilization of Frana Fantoni (Favero et al., 2010) in Recoaro village (Figura 4): it is a cylindrical excavation, temporary supported by braced micropile wall, with the internal surface subsequently covered with a cast-in place reinforced concrete wall.

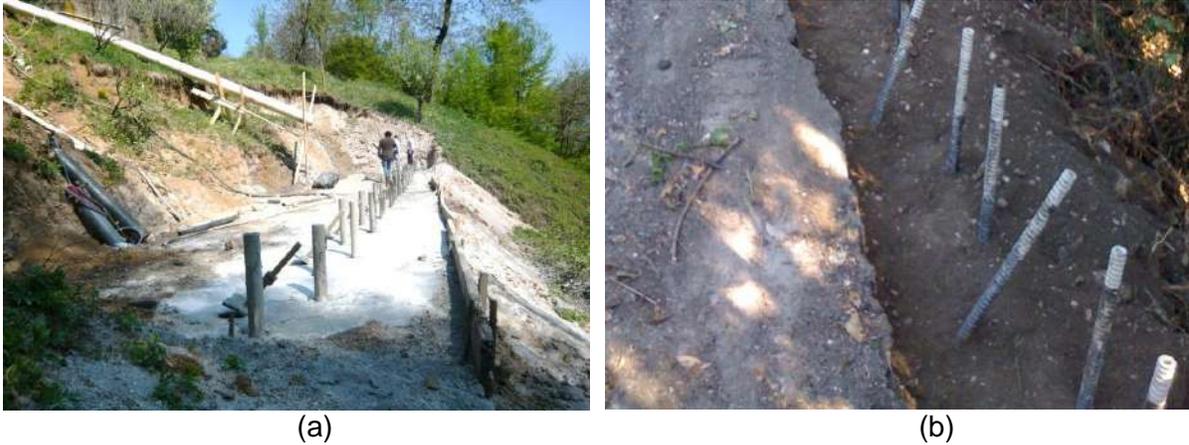
Figure 5. Examples of tie-back micropile wall in Vicenza Province: a landslide in Posina (a); a detail of micropiles easel with bar as reinforcement (b).

In Figure 5b it is possible to note that the standard steel tube adopted as resistant element in micropiles was substituted by the self-drilling bars typically used in soil nailing. This substitution is due to the economic and technical advantages provided by the self-drilling technique:

- 1) the bars, having a minor external diameter with the same steel section, require a smaller borehole and allow to get a thicker grouting cover for the corrosion protection of bars;
- 2) the self-drilling bars do not require the pre-drilled hole, thus speeding up the in-situ building up of the structure.

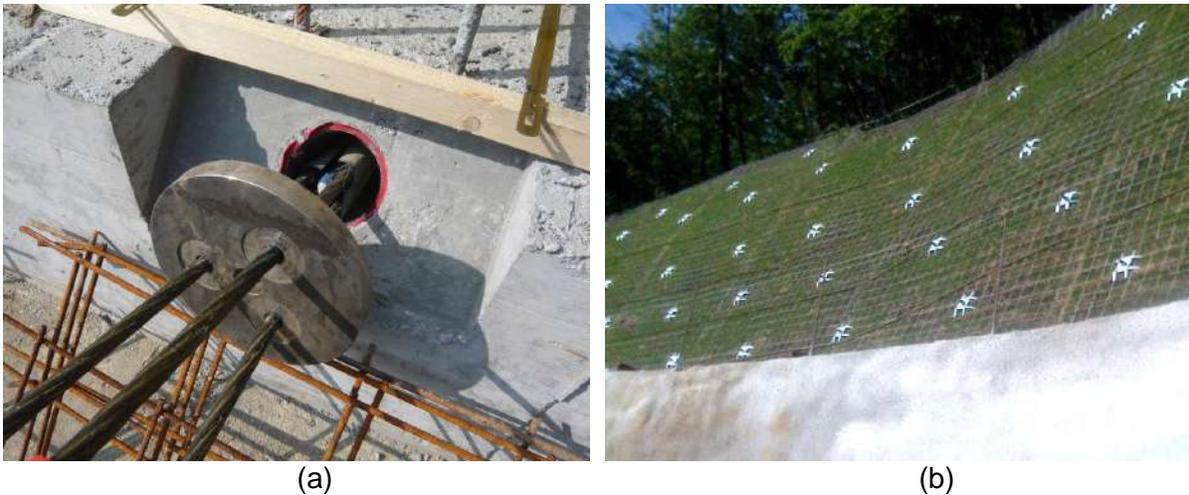
Figure 6. Anchor connection plate during installation (a); a soil nailing with flexible face in Vicenza (b).

For stabilizing a soil slope or fractured rock mass, anchors are usually installed in connection with an external retaining structure (wall, beam, net, micropile wall, etc.) (Juran and Elias, 1991) which distributes the anchor load on a large soil area avoiding soil punching (Figure 6a). Since they are pre-stressed (active reinforcement), they need a short-term performance verification (load test after installation), but also a long-term monitoring with a consequently higher maintenance cost. The main advantage of anchors is that they have no limits in length, of course considering the conventional applications, thus they may be used also in medium and deep-seat landslides.

Externally, the soil nailing bars are connected to plates and to a facing that, according with the European code (prEN-14490, 2010), may be rigid (formed by pre-cast or cast in place concrete plate, spritz-beton, etc.) or flexible (i.e. a rigid steel net) or soft (i.e. a very flexible steel or plastic net). In slope stabilization works, soft or flexible facing are used, because they allow plants and grass to grow up with limited environmental impact (Figure 6b).

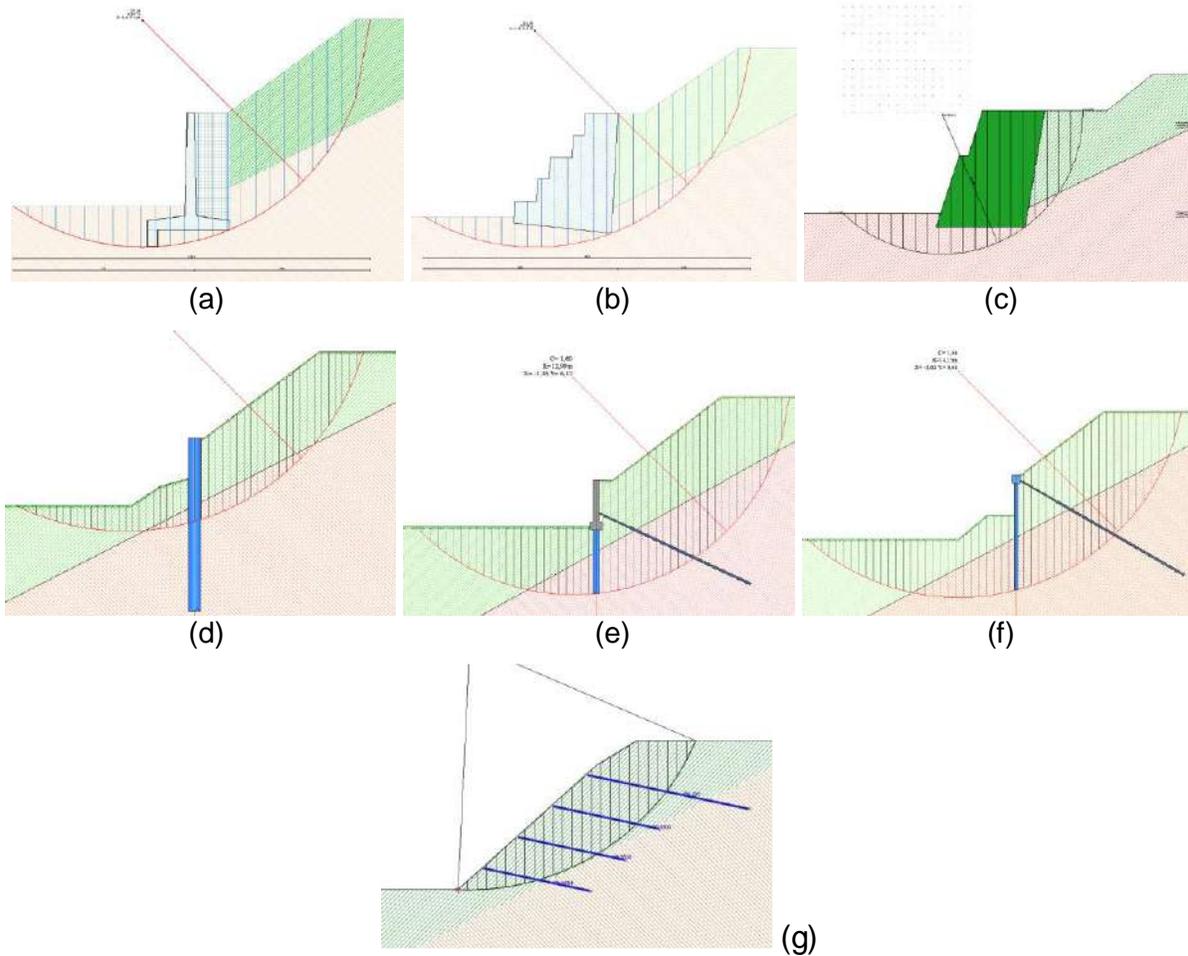
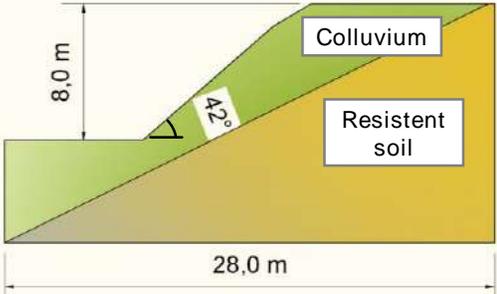
Figure 7. Interventions for the reference case: cantilever concrete retaining wall (a); gabion retaining wall (b); reinforced earth wall (c); line of drilled piles (d); tie-back micropile wall (e); tie-back wall with micropile (f); soil nailing (g).

The geometry of the reference slope is outlined in Table 1, while Figure 7 shows the various interventions considered in the analysis and the results of Limit Equilibrium (LE) analysis performed for each case with Fellenius method. Table 2 summarizes all the sizes (height of wall, base width, depth of micropiles, spacing, etc.) of reinforcement structures, together with the safety factor obtained in the LE analysis and the cost of intervention.

From the comparison, we note that the soil nailing and reinforcement earth wall are the cheapest solutions, followed by the wall founded on micropiles. The soil nailing costs less than half of the gabion wall price that is the highest, more than dowels.
